RE: United States Steel Corporation – Mon Valley Works – Clairton Plant
Additional Information Regarding Breakdown Reports #21256, 2157, and 2158
No. 2 Control Room, No. 5 Control Room, and Battery Stacks

BACKGROUND INFORMATION REGARDING COKE OVEN GAS PROCESS

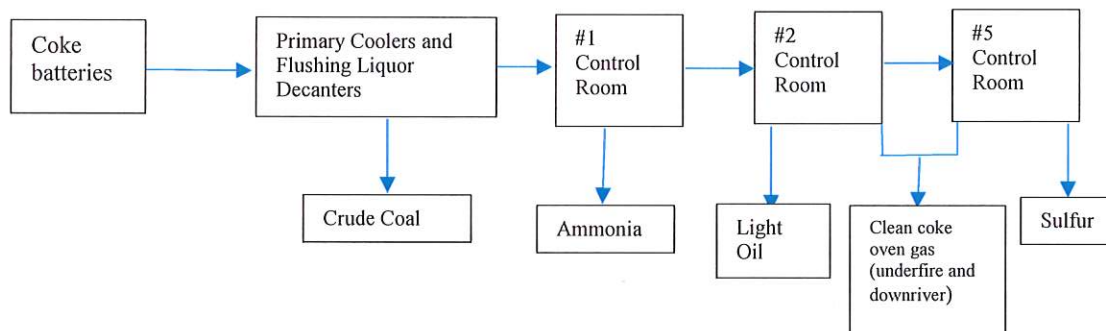
To better understand the breakdown and its impact of operations, a brief explanation of the coke oven gas process is provided. Coke oven gas is processed through a series of unit operations at the U. S. Steel Clairton plant to recover various by-products, and clean the coke oven gas for downstream fuel gas use. A simplified block flow diagram of the coke oven gas flow through these unit operations, and byproduct recovery at each unit operation is shown below:

The #2 control room process is a cryogenic gas separation facility, and light oil recovery facility. It consists of 24 main regenerator vessels which operate at very low temperatures (-258 F), which cool the coke oven gas and separate the gas into various streams for downstream fuel consumption and further by-product recovery, 16, two-stage, 1500 horsepower axial compressors, which provide vacuum and compression for the main regenerator unit operation, and light oil recovery process, and a light oil recovery plant, which is a series of heat exchangers, and another small cryogenic unit operation, consisting of 4 light oil regenerators that recover the light oil from the coke oven gas.

During normal operation, 100 percent of the coke oven gas must pass through the entire process up to #2 control room. At #2 control room, this coke oven gas stream is split into different gas streams, including (1) clean downriver coke oven gas, (2) clean underfire coke oven gas, and (3) carbonate feed gas. The clean downriver gas, goes to consumers throughout the Mon-Valley Works. The clean underfire gas is used to heat the batteries at Clairton. The carbonate feed gas represents approximately 15% of the total gas volume (~30 MMSCFD of gas flow for 11,700 tons/day of coke production). This carbonate feed gas stream is sent on to the #5 control room for sulfur removal. Once the sulfur has been removed from the carbonate feed gas, this gas is combined with the clean downriver gas, for downstream consumption.
